## Restaurering av hjemmene til Rainis og Aspazija

| Prosjektnavn: | Restaurering av hjemmene til Rainis og Aspazija<br><i>Eng. Restoration of the Museum of Rainis and Aspazija</i> |

Sluttrapport 27520213 Restaurering av dikterhjemmene til Rainis og Aspazija av Eivind Falk 2016

## Project Restoration of the Museums of Rainis and Aspazija

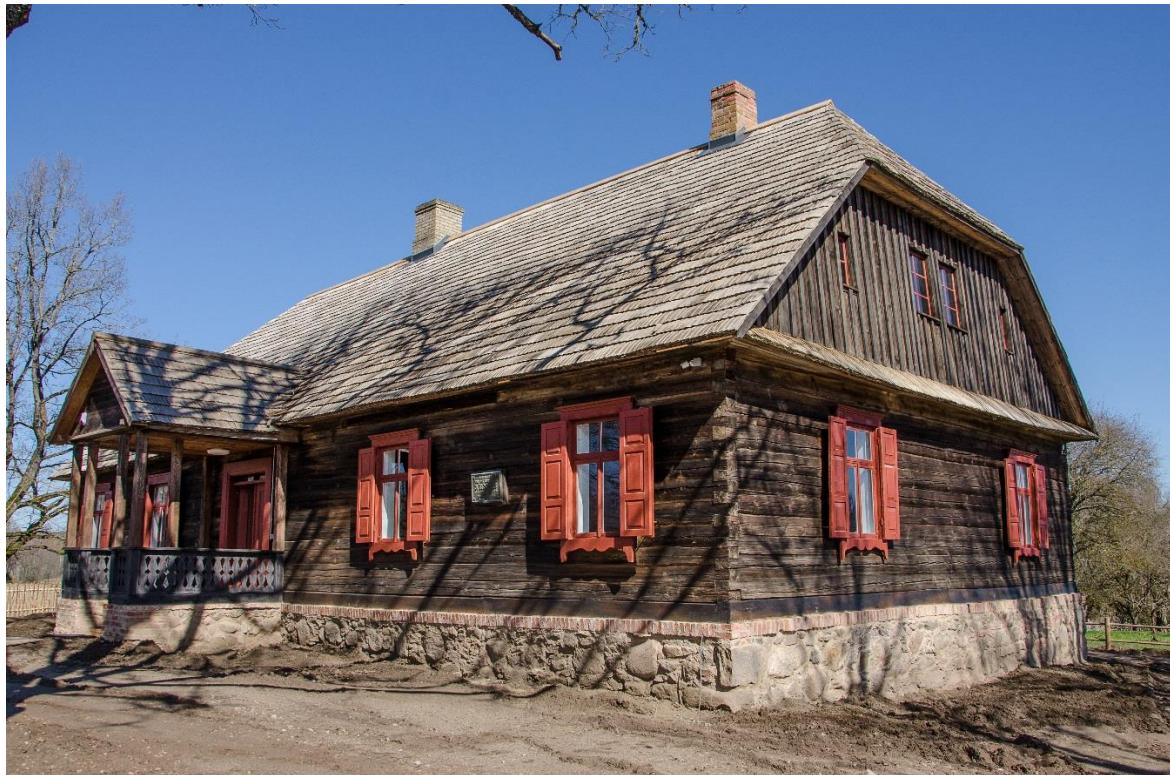
Rainis' barndomshjem «Tadenava» i Dunava etter restaureringsarbeidet (Foto: Girts Kindzulis)

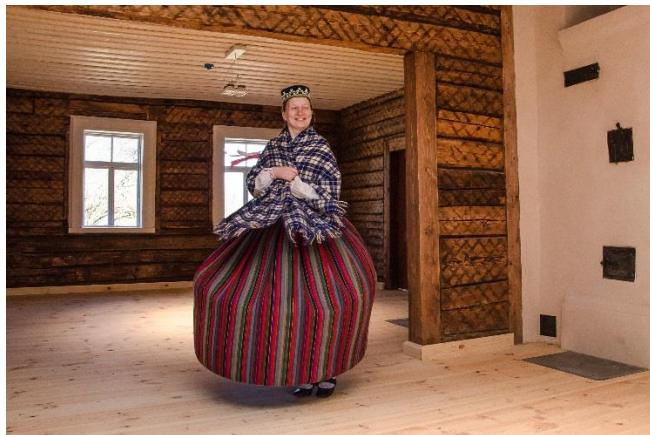
*Fra gjenåpningen av «Tadenava» i Dunava. Legg merke til merkene etter sporene etter feste for rapping på tømmerveggene (foto: Girts Kindzulis)*

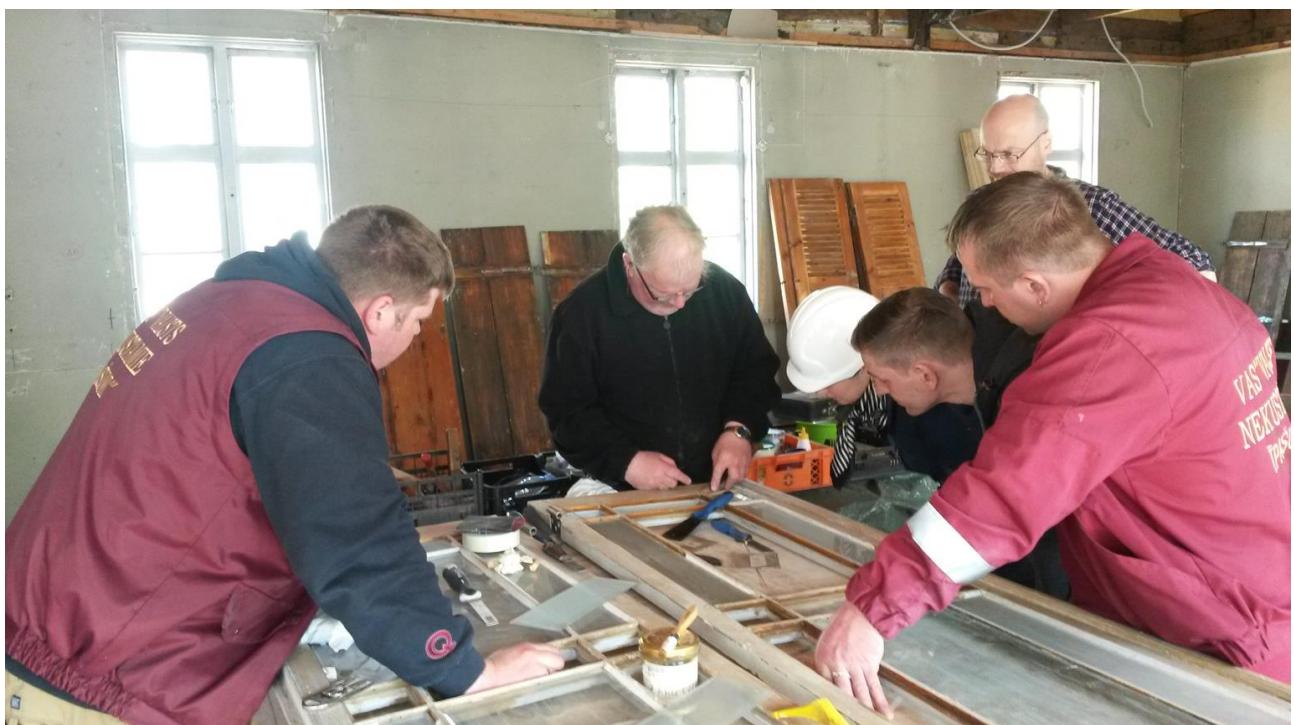
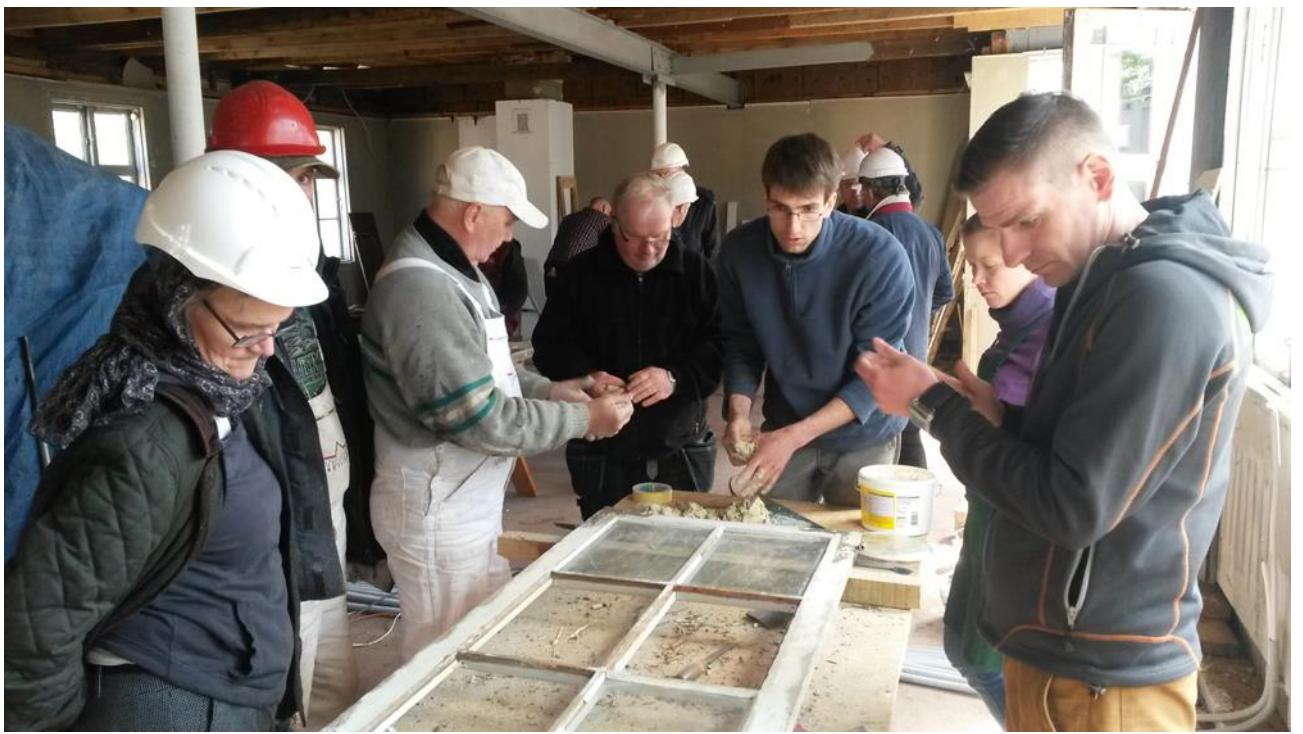
Jarl Styve (i midten) instruerer i vindusrestaurering. I bakgrunnen Kolbjørn Vegar Os

*Jarl Styve (i midten) instruerer i vindusrestaurering*
